60-7-106

SUBJECT: "Intercycle Evaporator Explosion, Building 3019," and
"Decontamination of Building 3019." - Papers Presented
at a Chemical Technology Division Seminar, July 19, 1960

INTERCYCLE EVAPORATOR EXPLOSION, BUILDING 3019

DECONTAMINATION OF BUILDING 3019

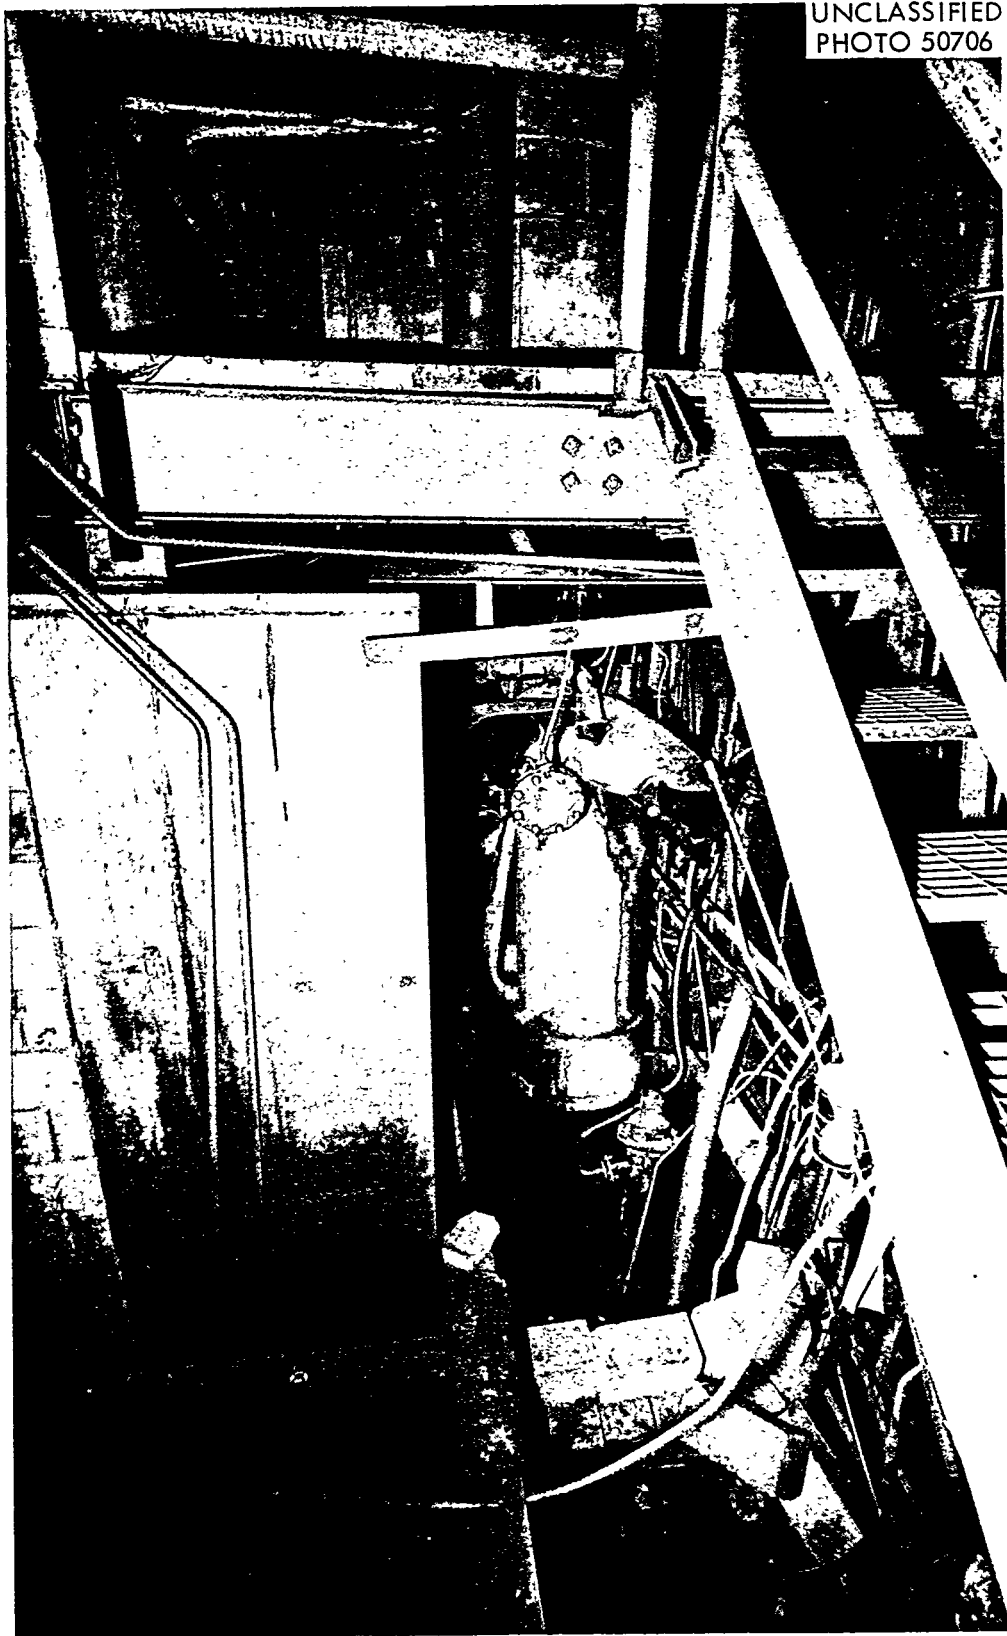
Fig. 3. Evaporator Cubicle.

Figure 3 through 9 are photographs of the evaporator and cell 7 after the explosion.

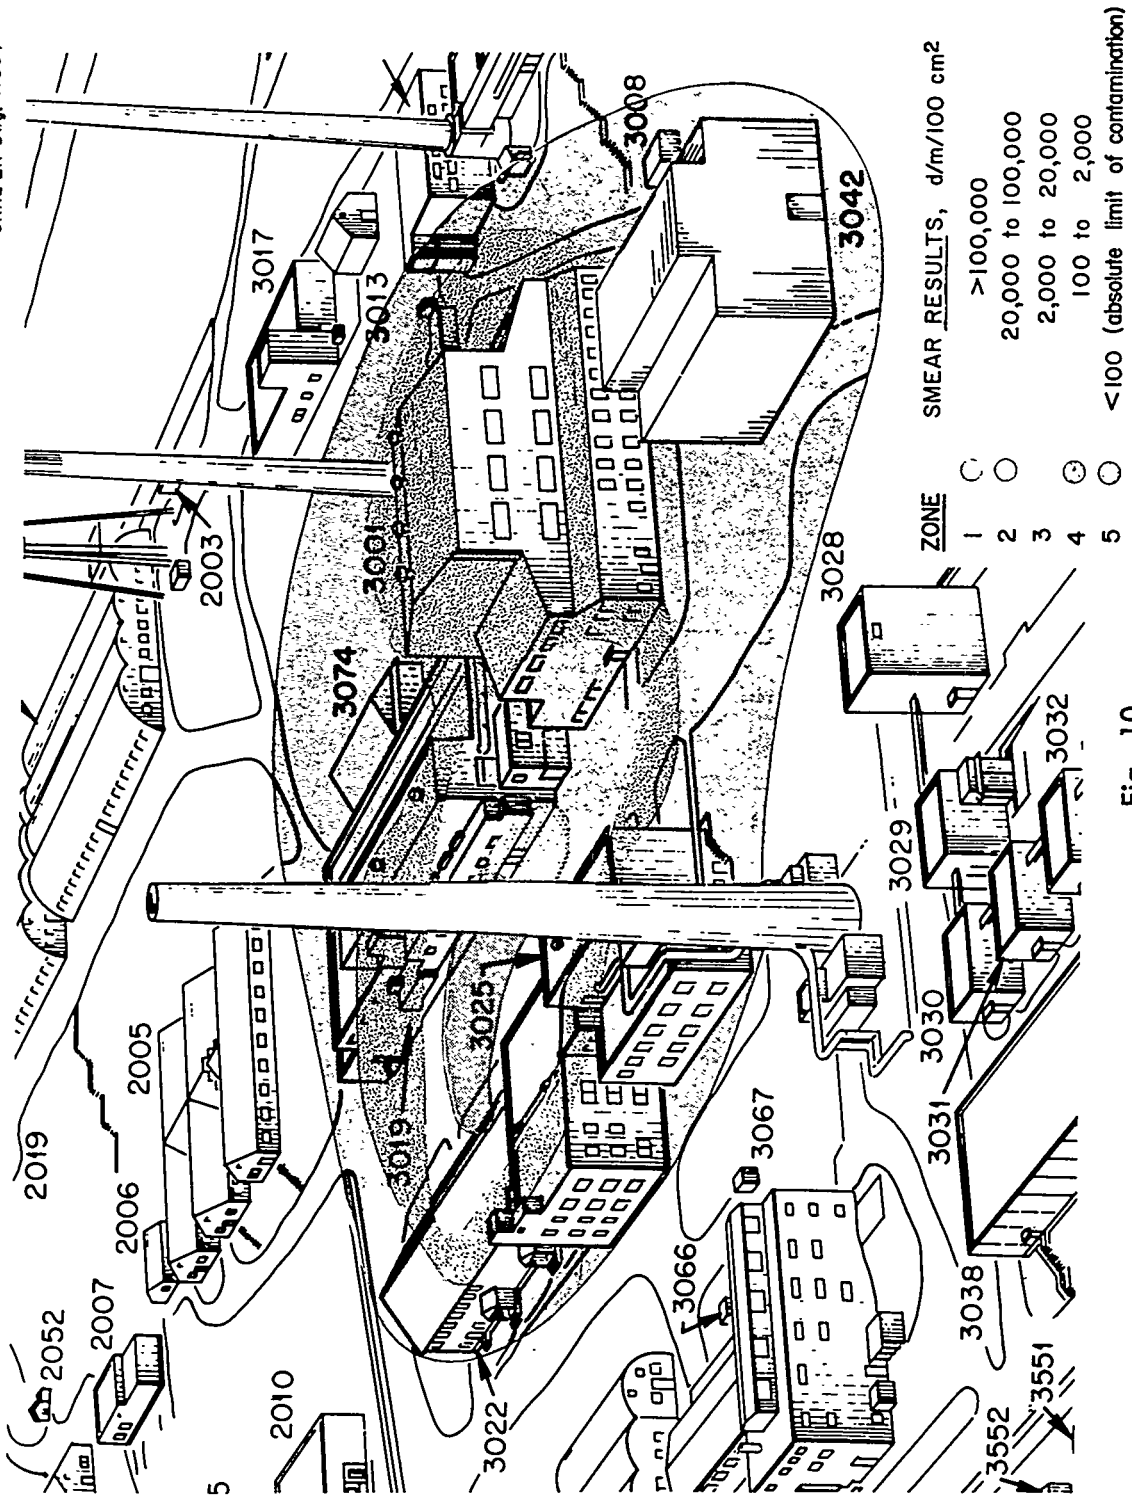
Fig. 10.

The area was smeared and Figure 10 is a map of the fallout pattern. One microgram of plutonium-239 undergoes 1.36×10^5 alpha disintegrations per minute and transferable contamination ran as high as 7.2×10^6 alphas disintegrations per minute per square inch. The central area contained one body burden of plutonium per 100 cm^2 . Some beta-gamma activity (later identified as $\text{Zr}^{95}\text{-Nb}^{95}$) was found but it was not significant. The interior of the Graphite Reactor building became contaminated and the building was evacuated. Some contamination was found in other buildings but it was slight and was readily cleaned up.

The decision was made to immediately "fix" the plutonium with paint on the buildings and grass, with asphalt on the roads, and with either paint or tar on the roofs.

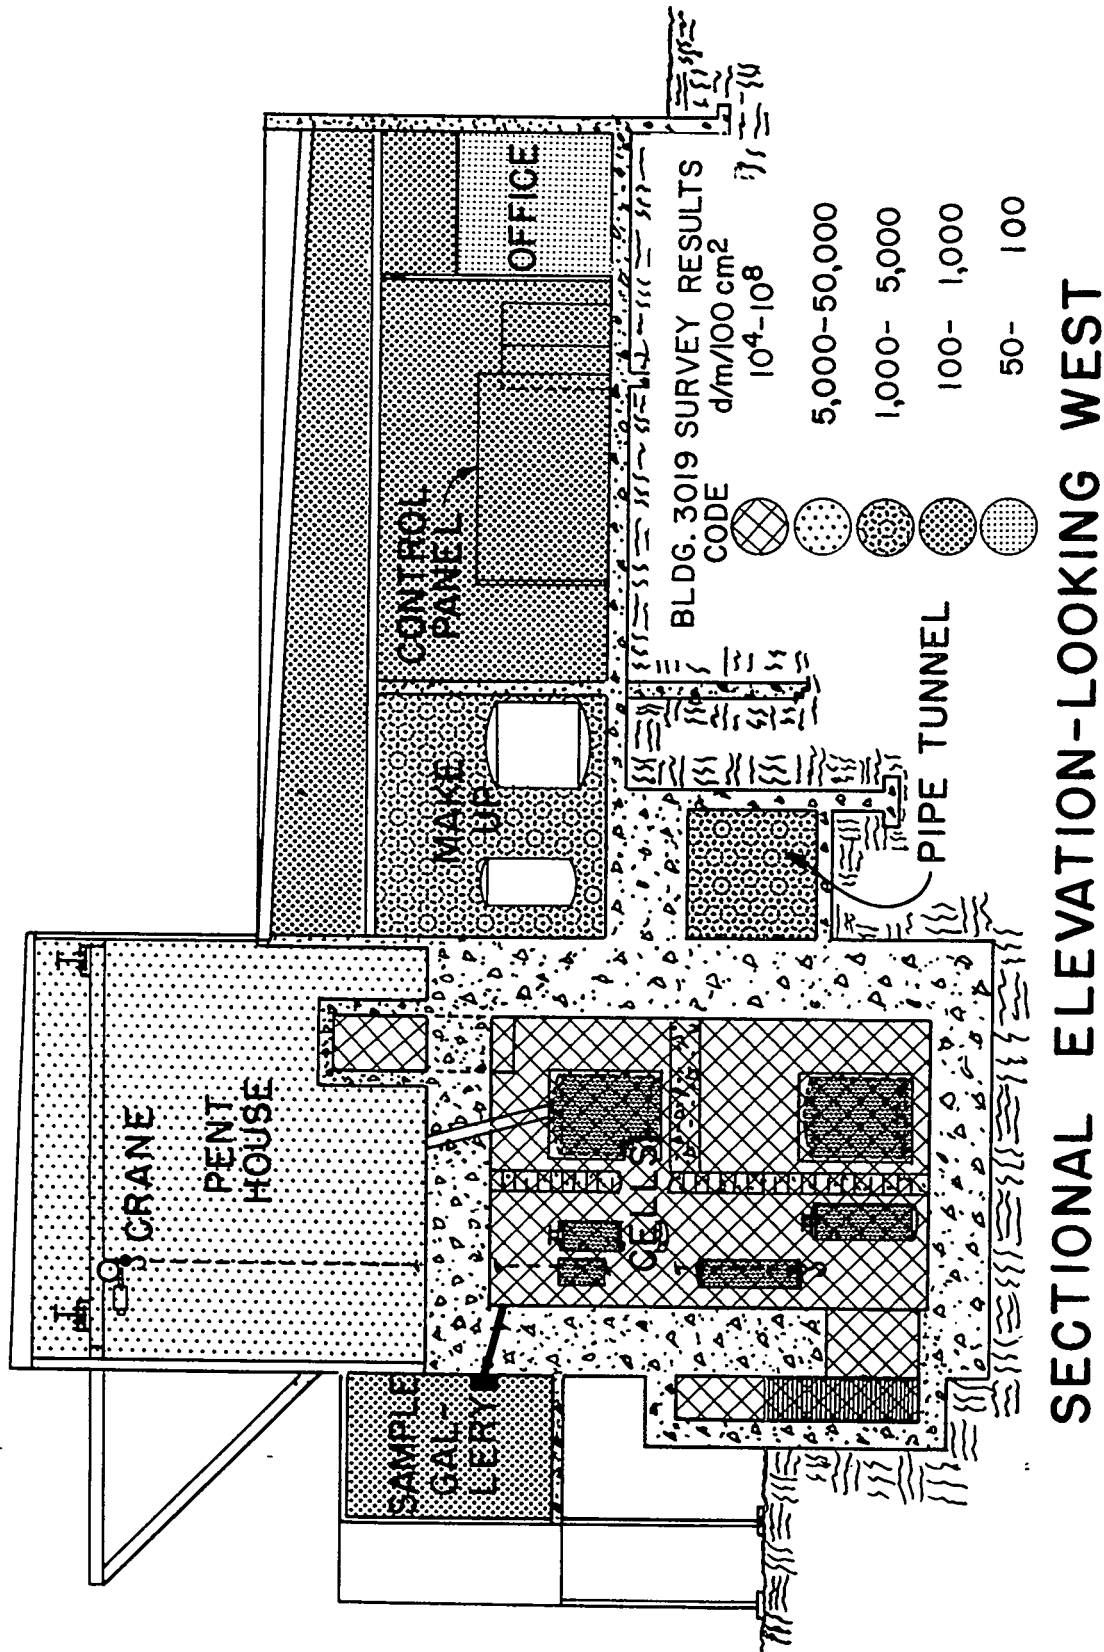
Figure 1 represents a sectional view of the pilot plant building and shows the levels of contamination inside the building after the explosion. I would like to emphasize the fact that high levels of contamination existed in several areas of the pilot plant prior to the evaporator explosion and the contamination levels represented by this figure and the decontamination effort expended during the past 8 months were not due entirely to the Pu contamination released by the explosion of November 20. Cells 6 and 7, where the evaporator is located, were the most highly contaminated areas with smear counts running as high at 10^8 d/m/100 cm². There are a total of 38 access holes penetrating the walls and ceiling of Cells 6 and 7; which are either completely open or partially filled with piping. The distribution and cross sectional areas of these access holes are as follows: penthouse - 19 holes (2.85 ft²), pipe tunnel - 11 holes (2.15 ft²), sample gallery - 2 holes (0.4 ft²), make-up area - 6 holes (1.18 ft²). The pressure from the explosion forced activity through these holes and contaminated the areas as indicated on Figure 1. The penthouse was the most highly contaminated area outside of the cells with smear results ranging from 5,000 to 50,000 d/m/100 cm². Direct probe measurements were as high as 800,000 d/m/100 cm². The sample gallery, make-up area and pipe tunnel were contaminated to approximately the same levels. Smear results in these three areas ranged from 1000 to 5000 d/m/100 cm². There are two open doorways between the make-up area and the control room and a small amount of activity drifted into the control room and office areas and they were contaminated to the levels as indicated in Figure 1.

Fig. 1. Bldg. 3019 Contamination Levels after the Evaporator Explosion.

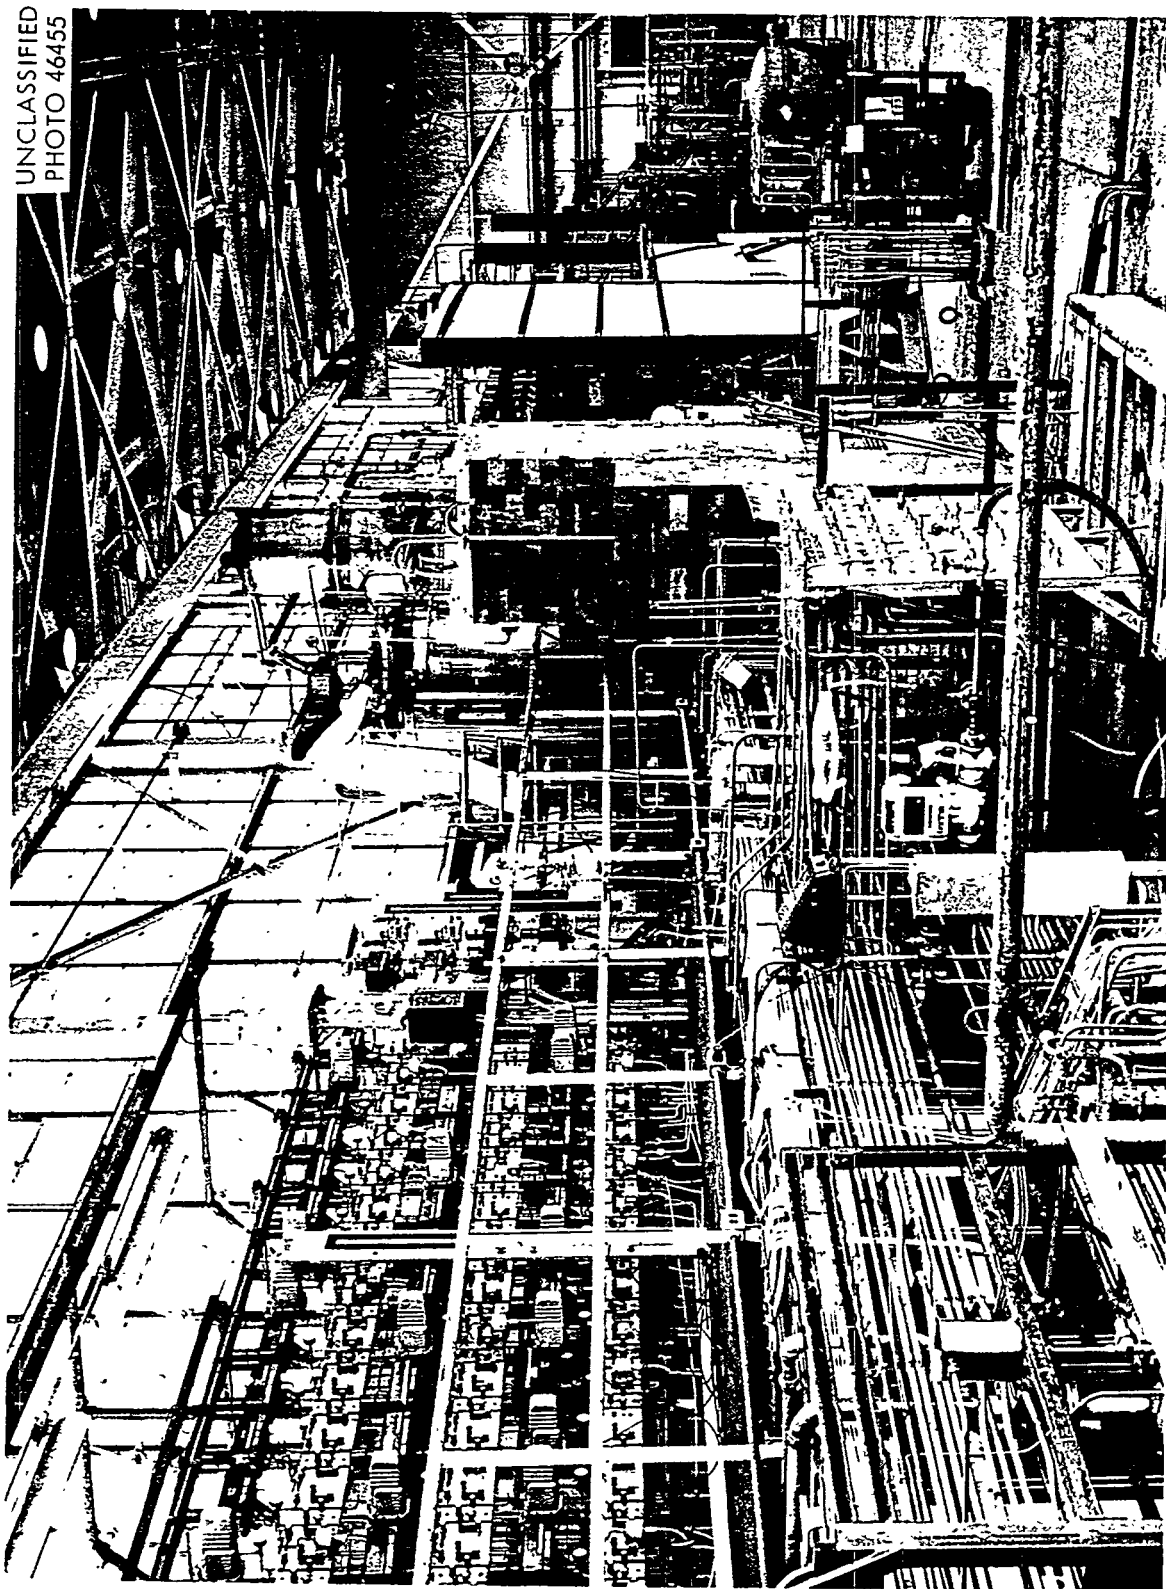
Fig. 2. Bldg. 3019 Penthouse Area.

Figure 2 is a picture of the penthouse area which is located over the seven hot cells of the pilot plant and was the most highly contaminated area outside of Cells 6 and 7. The area is approximately 165 ft in length, 30 ft wide and 30 ft high and it contains instrument transmitter racks, cold make-up tanks, hot process equipment in lead brick cubicles, a quick disconnect panel and large quantities of instrument tubing, water, steam, air and process piping. This figure also shows the building structural steel and support beams for a 10 ton crane. This ceiling proved to be one of the most difficult areas to decontaminate. Figure 3 is another view of the penthouse ceiling and shows the portable scaffold that was installed to facilitate the ceiling clean-up. A number of methods for removing the fixed contamination from the painted surfaces of the penthouse were tried. These include scrubbing with stiff brushes, detergent and water, scrapping off all loose paint, sanding by hand and mechanical sanders, but the only effective method found was to remove the paint almost completely with paint remover and paint scrapers followed by a good scrubbing with soap and water. This method was applied and proved effective on all painted surfaces.

The last complete survey of the penthouse floor, walls and ceiling revealed that the contamination level in this area still exceeded the painting specifications even after the large amount of work that had been done there. To further decontaminate the penthouse floor, a rotary scarifier was used to remove a 1/8 in. layer of concrete. The entire floor was then probed for hot spots and areas probing $> 3000 \text{ d/m/100 cm}^2$ were chipped out with air hammers. The floor area was then reprobbed for hot spots and any found were removed by chipping.

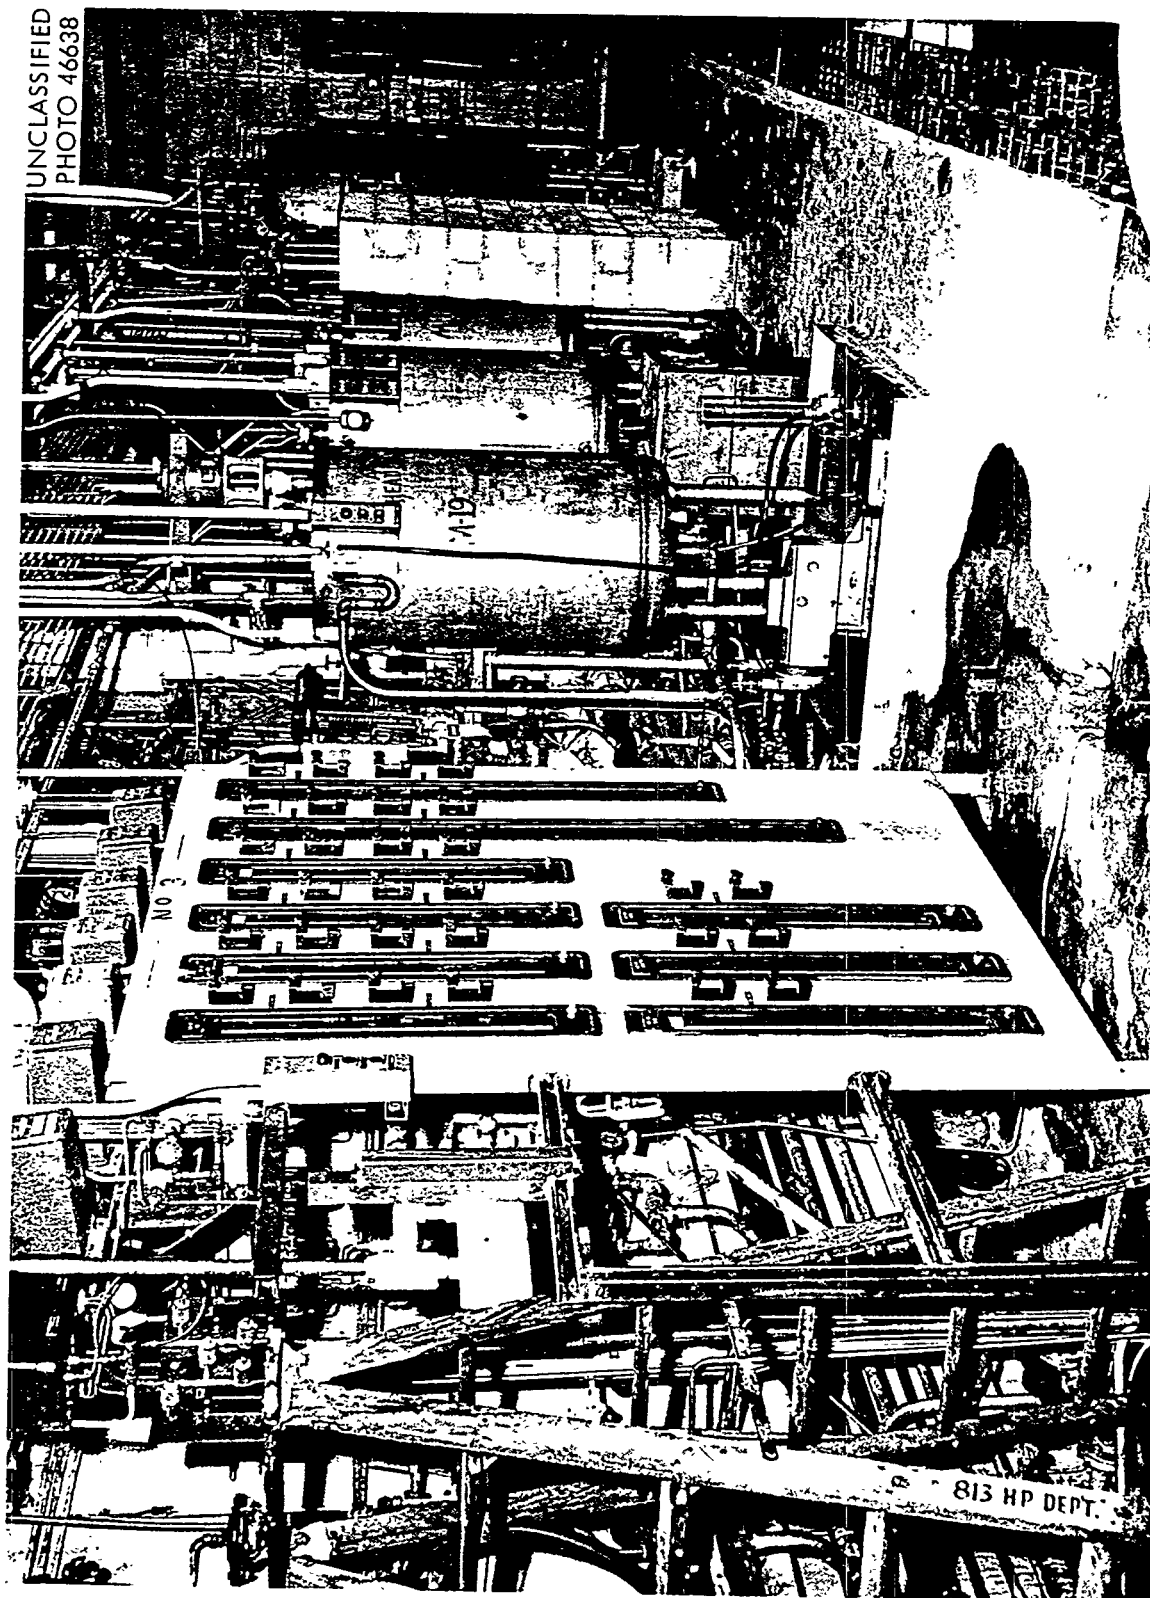
Fig. 4. Bldg. 4019 Cold Solutions Make-up Room.

Figure 4 is a picture of the cold solution make-up area and clearly shows the condition of the concrete floor resulting from acid spills and heavy traffic. The only way this condition could be decontaminated was to chip out the entire floor and repour a new one. This has been done in the make-up area and in addition a stainless steel liner has also been installed.

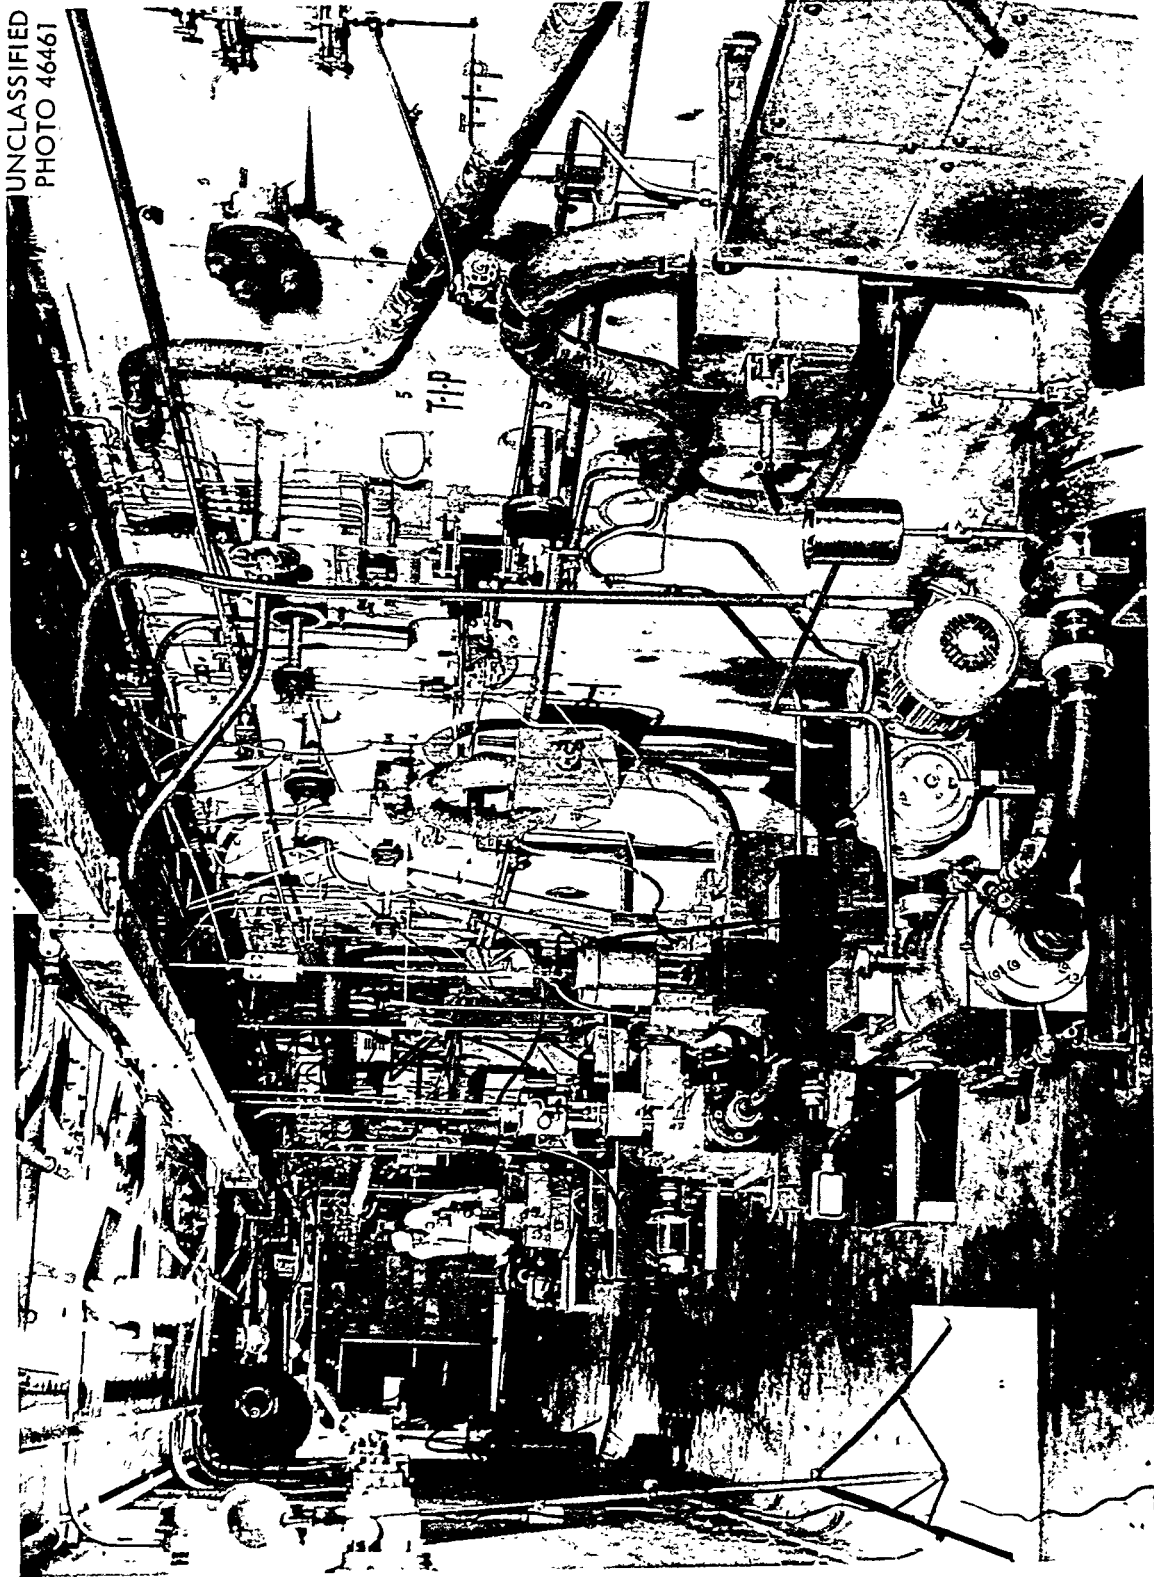
Fig. 5. Bldg. 3019 Pipe Tunnel.

Figure 5 is a picture of the pipe tunnel where a number of pulser drive units are located. Contaminated grease and oil were cleaned from these drive units with a commercial product called Gunk. The painted walls and ceiling were decontaminated with paint remover, while the stainless steel floor, piping and lead shielding were cleaned with dilute HNO₃.
